**PRELIMINARY ENGINEERING REPORT  
FOR  
WATER DISTRIBUTION SYSTEM IMPROVEMENTS  
HEDRICK, IOWA  
2021**

Tower Visual Inspection Report  
Viking Industrial Painting  
July 2020

**Visual Inspection - July 2020**

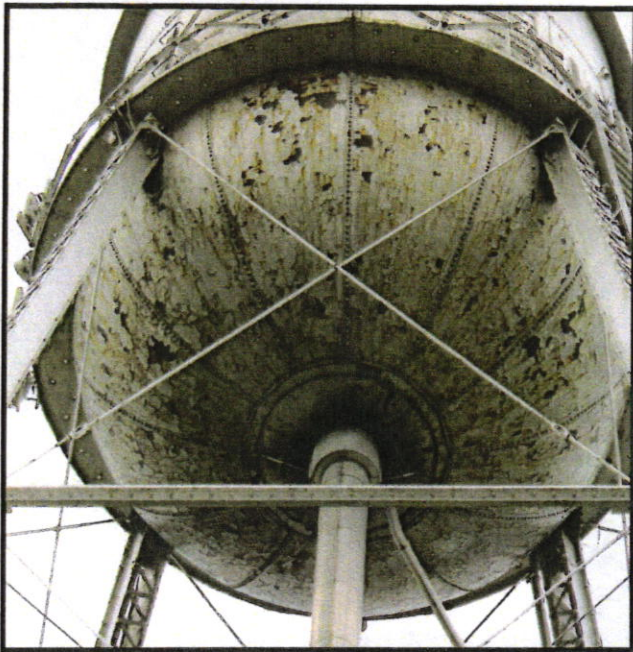
Exterior coatings in very poor condition and will require full removal prior to new coating system application.

- Exterior coatings are in poor condition and in need of renovation. Full blast removal of all coatings are needed, and a containment would be required to contain spent blast material and coating debris. Existing coatings likely contain lead so proper disposal of special waste would be required.

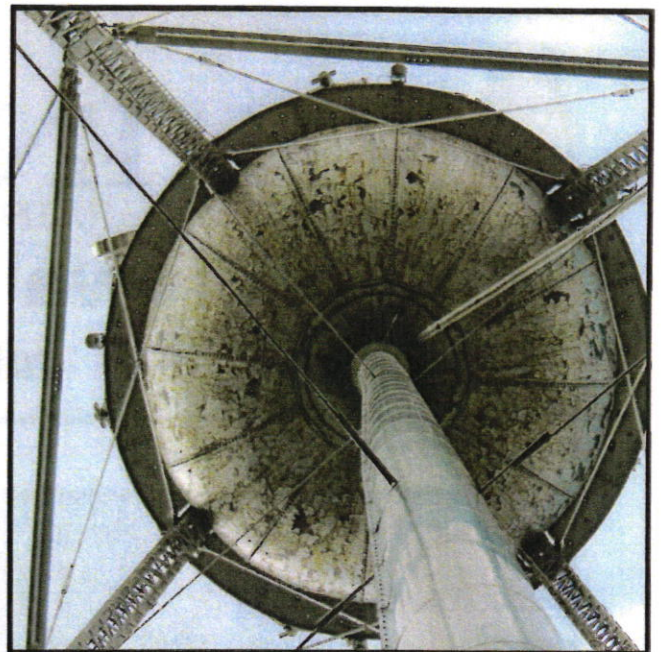
Riser insulation jacket in good condition.

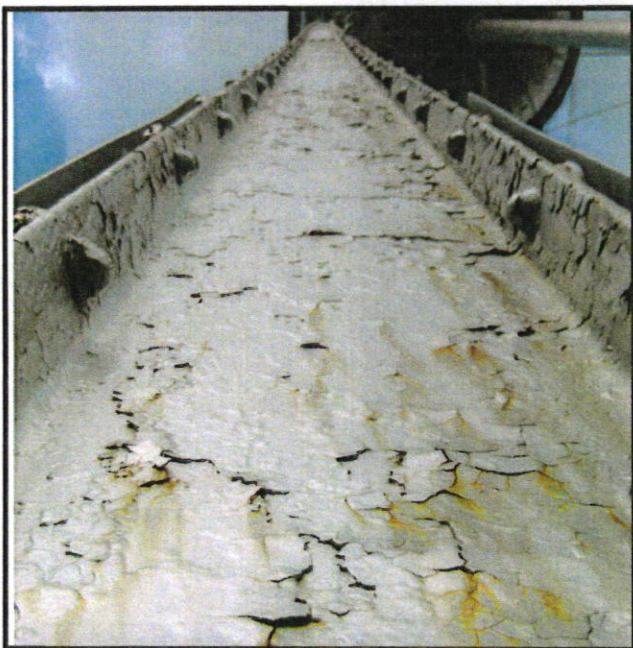
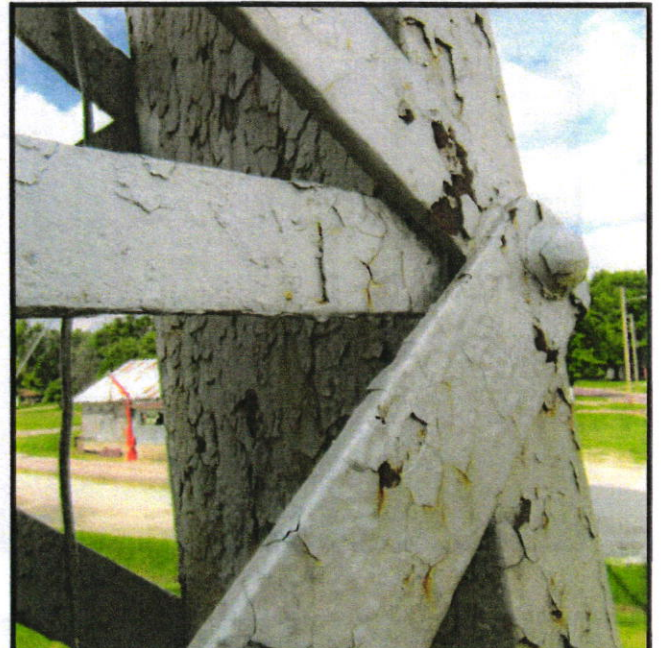
Cracking and peeling of several layers of paint.

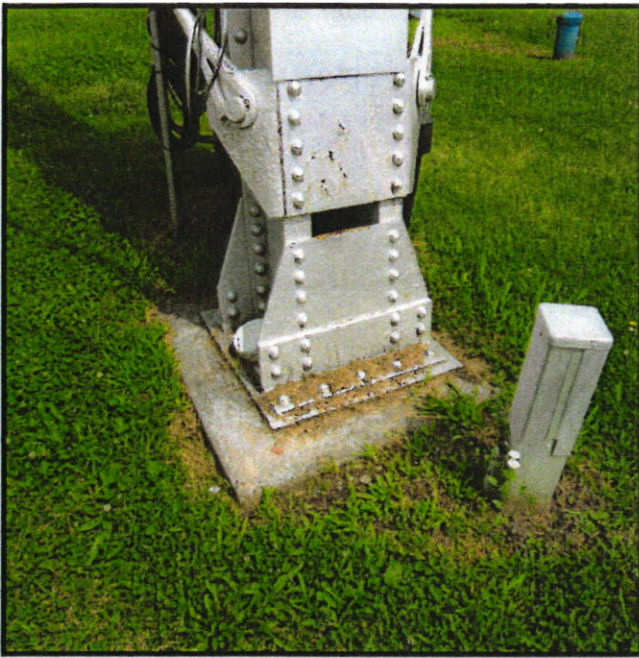
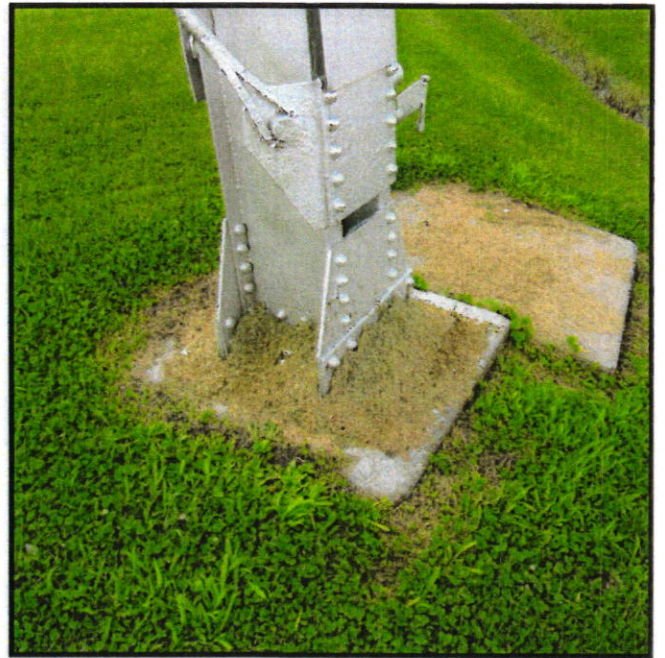
Foundation pads are in good condition above grade.

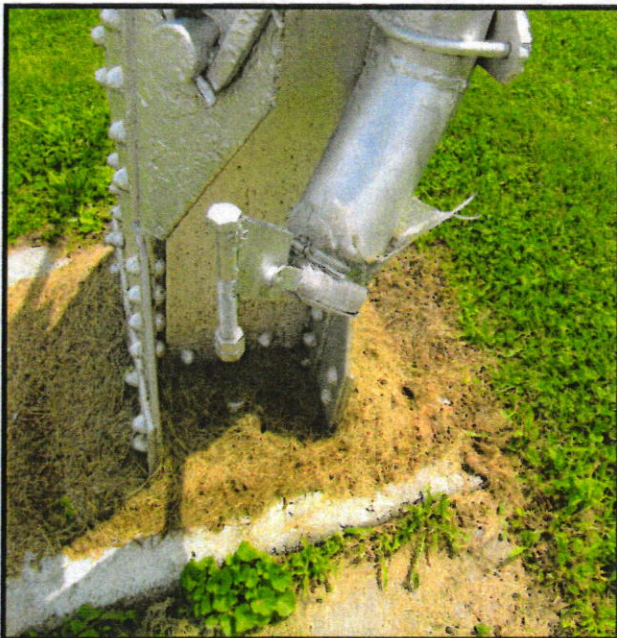
Overflow terminates above grade and has screen and flapper gate.

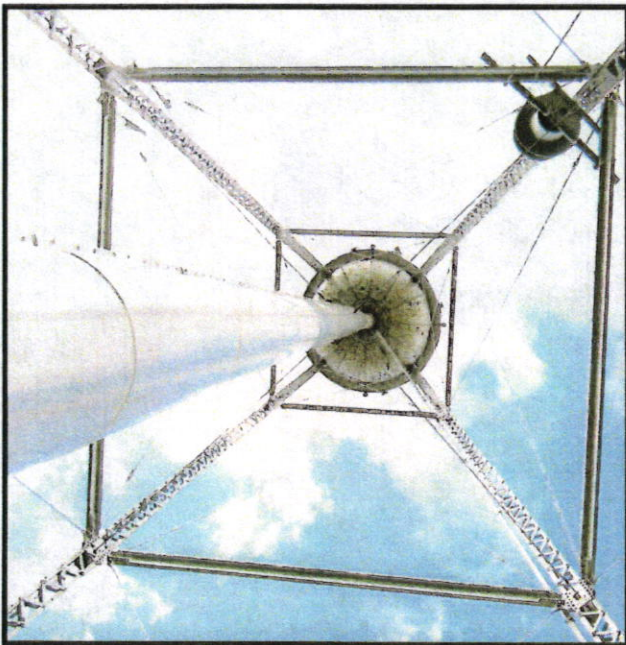
Insulation jacket in good condition.

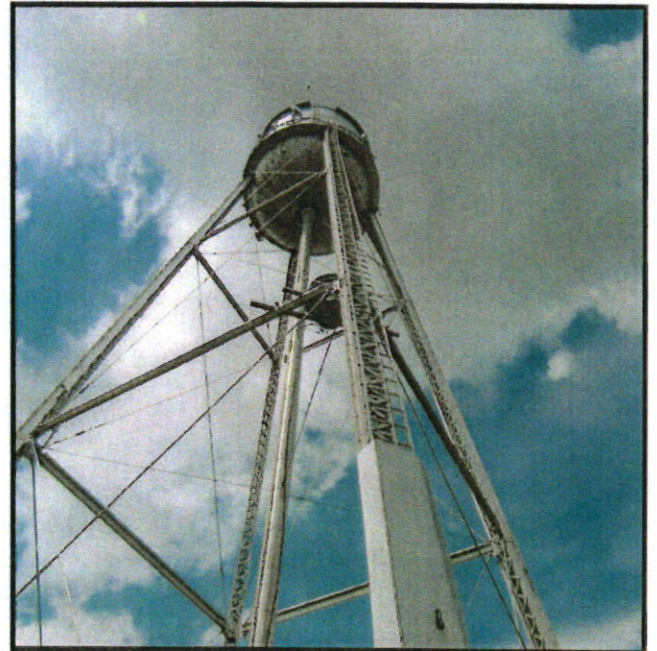
Ladder is new OSHA compliant ladder with cable safety climb and locked ladder gate.

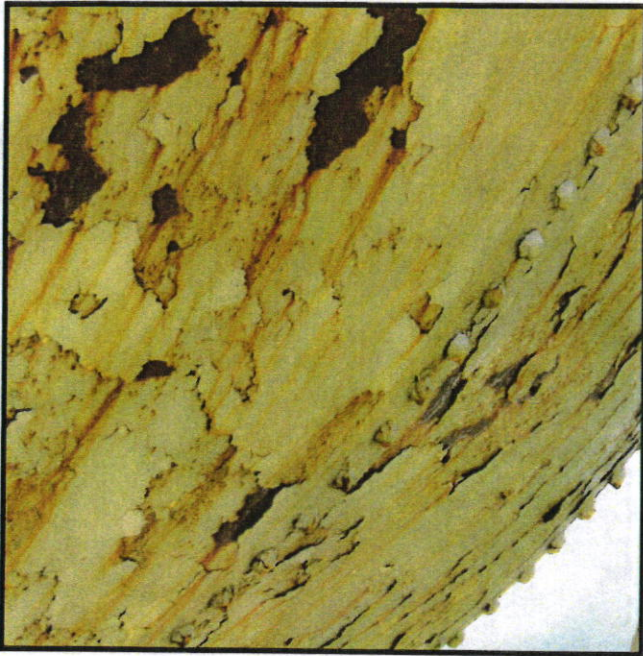
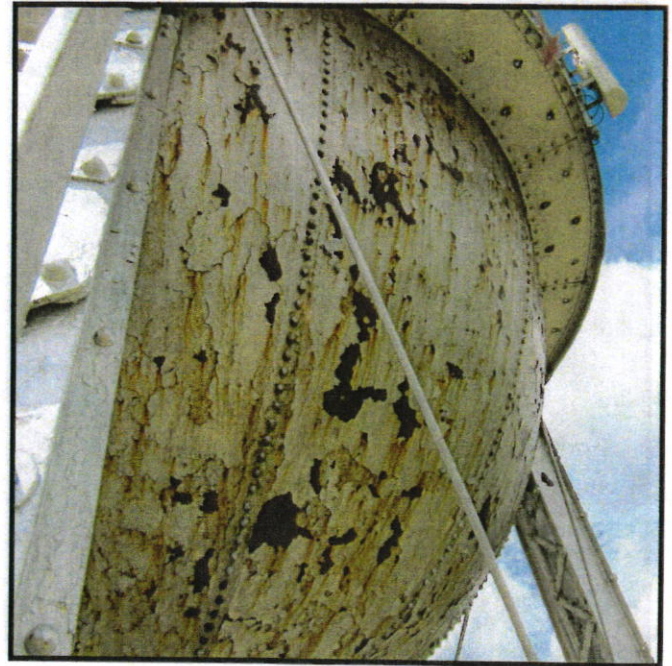
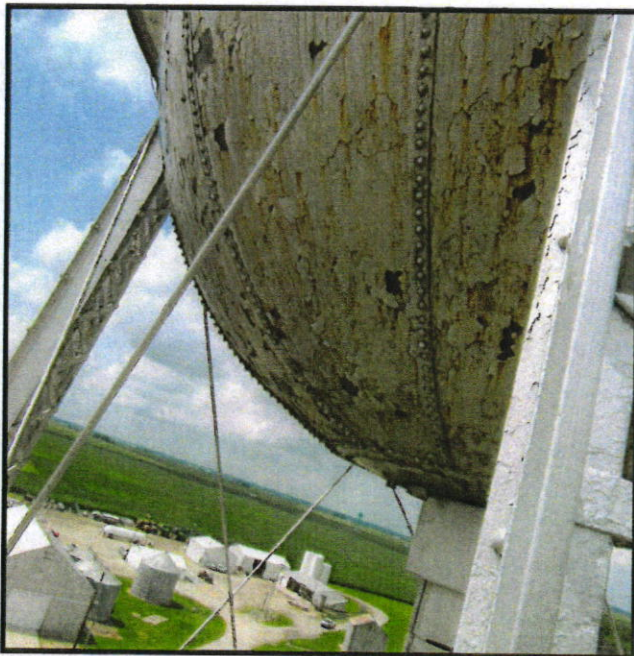
Tank belly coating failure.

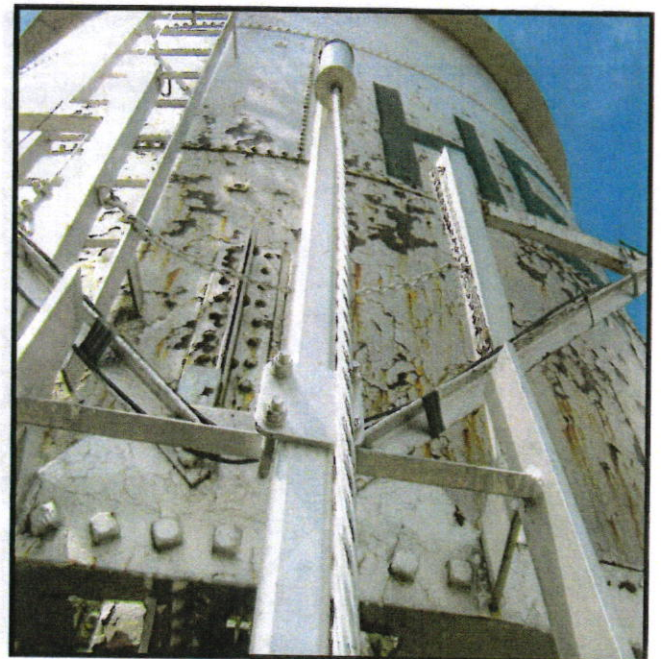
Cable safety climb bracket properly fastened to ladder.

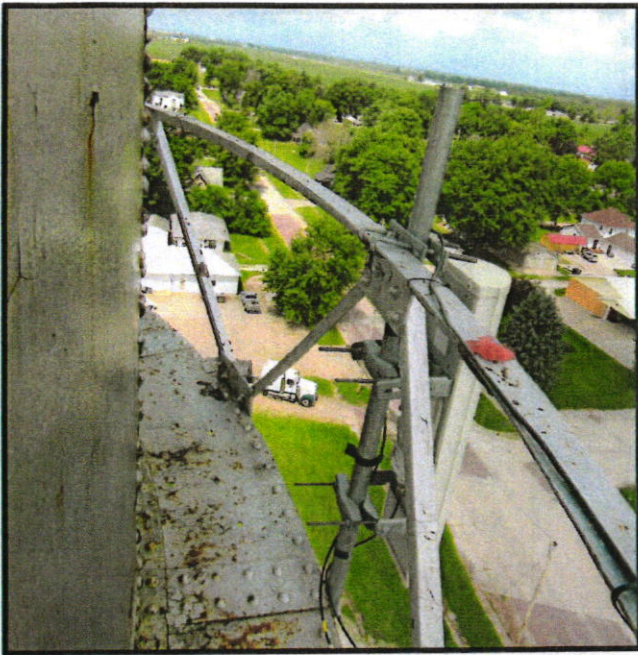
Balcony railing not dimensionally compliant with OSHA. Lacks mid-rail, toe plate, and is not proper height.

- Roof vent should be replaced at time of coating renovation.
- Secondary manway should be installed at time of coating renovation.
- Balcony railing, due to not meeting OSHA standard, and due to damage of top rail, should be modified or fully replaced.

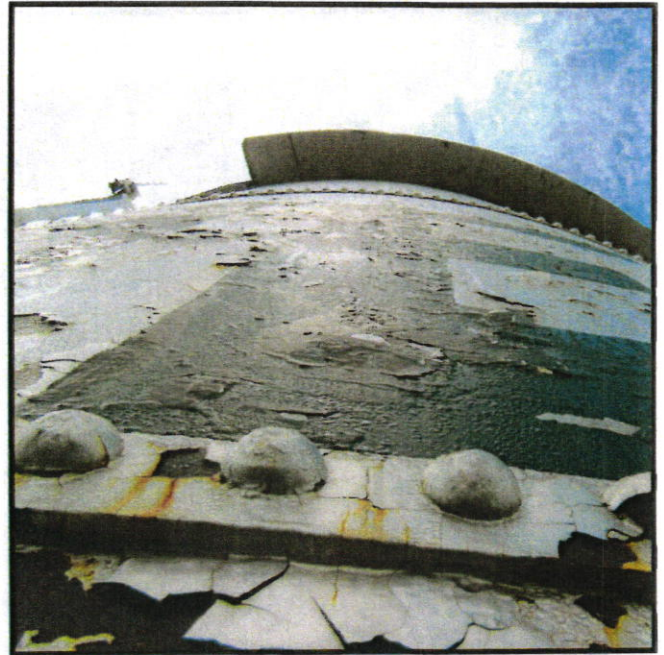
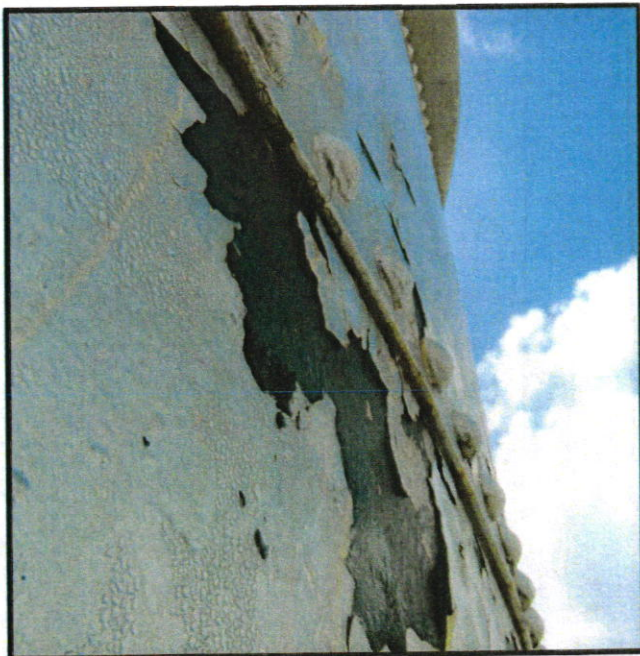
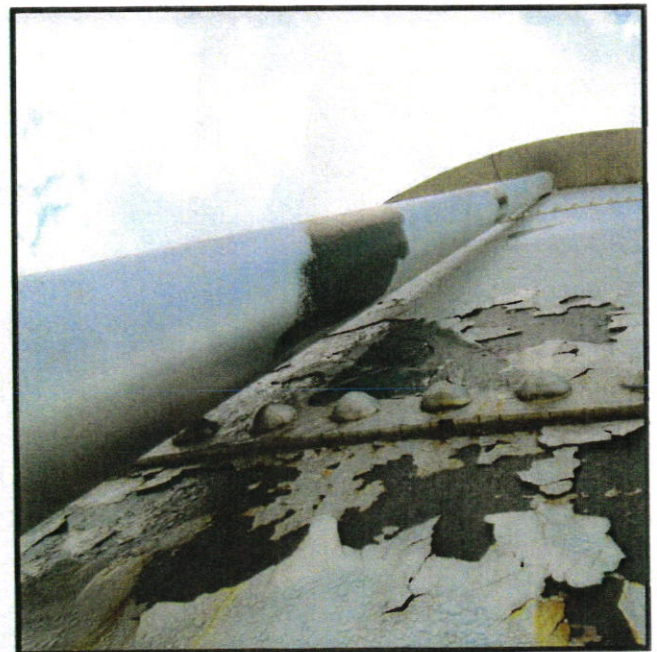
Coating failures on tank shell.

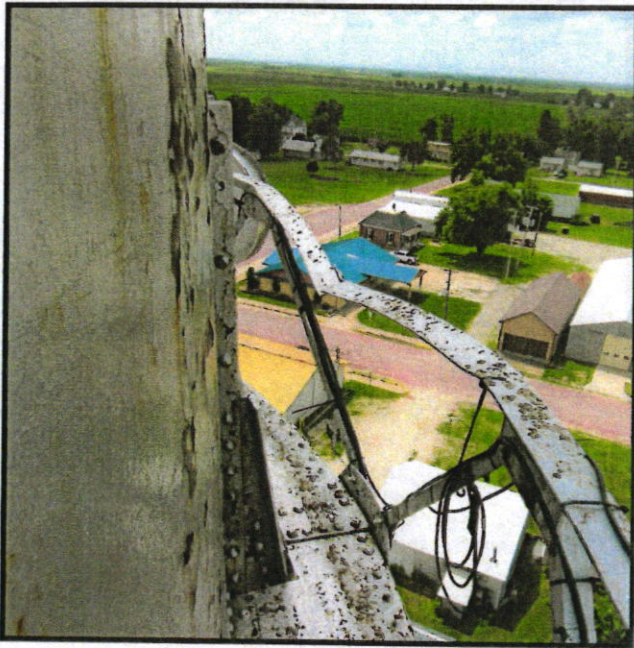
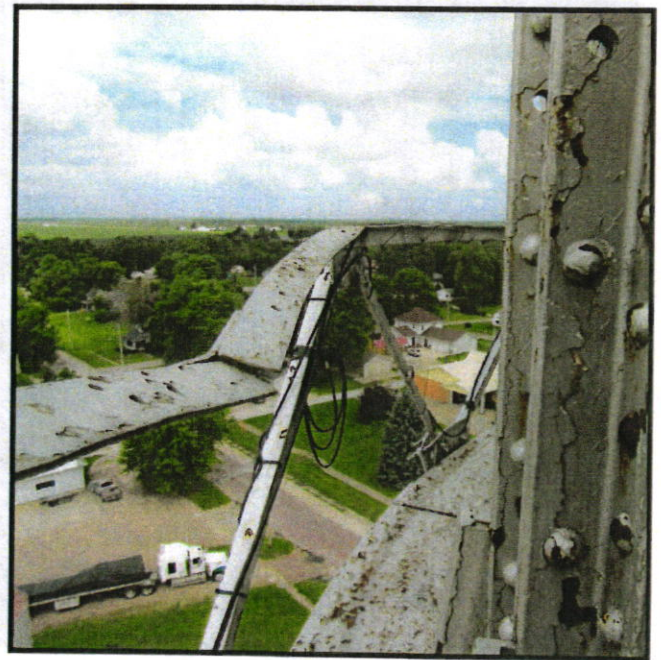
Balcony top rail damaged and bent in towards tank shell.

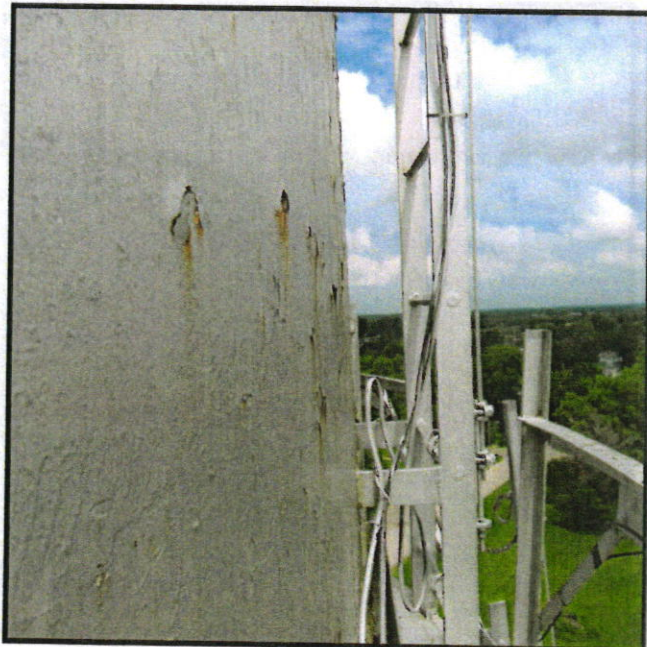
New OSHA compliant shell ladder.

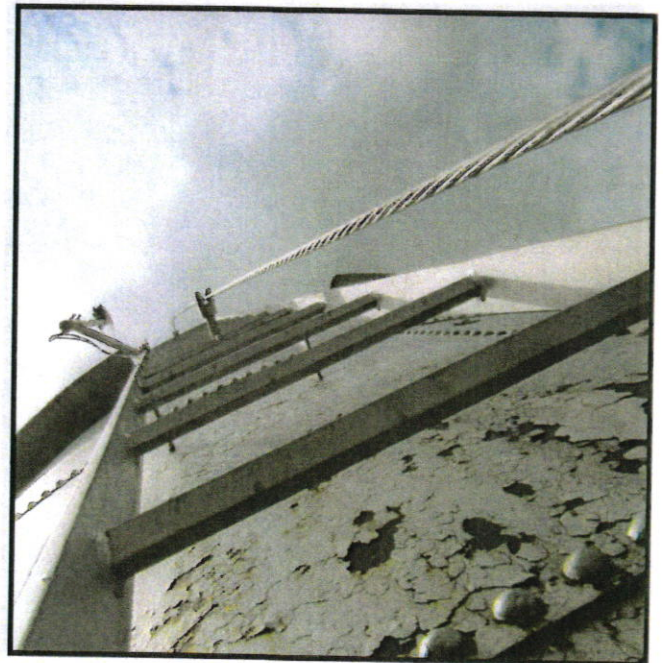
Shell ladder equipped with cable safety climb.

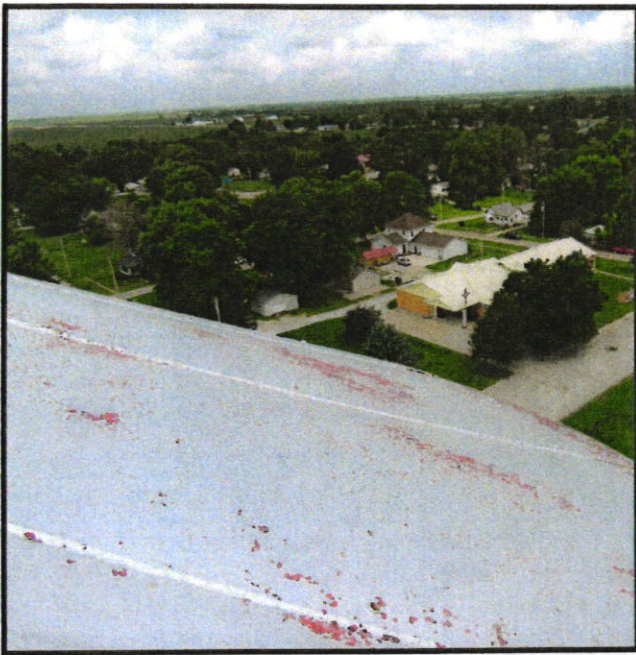
Roof coatings overall holding up well in, but some intercoat adhesion loss.

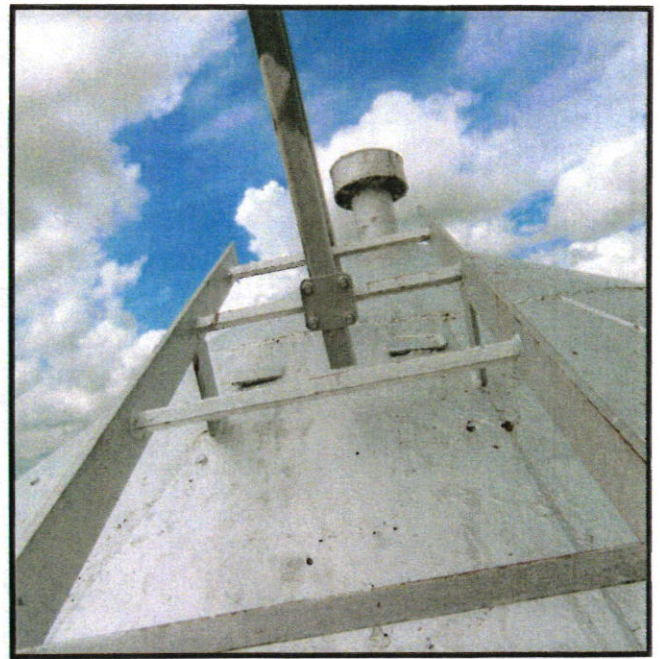
Shell/Roof ladder safety climb bracket properly fastened to ladder.

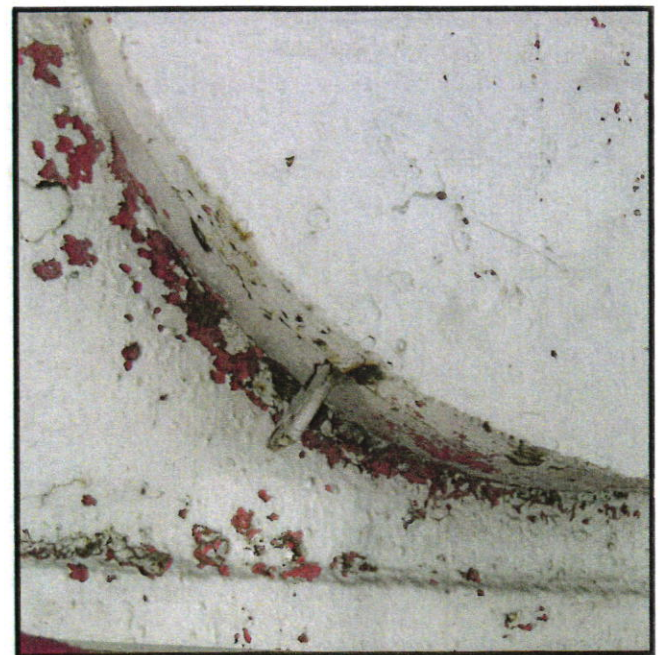
Roof manway hasp has broken off so lid can not be secured with lock or fastener.

- Roof could be stitch or seal welded to tank shell to remove eave gap and improve integrity.
- Roof manway hasp should be repaired to allow for lock or fastener to be used.

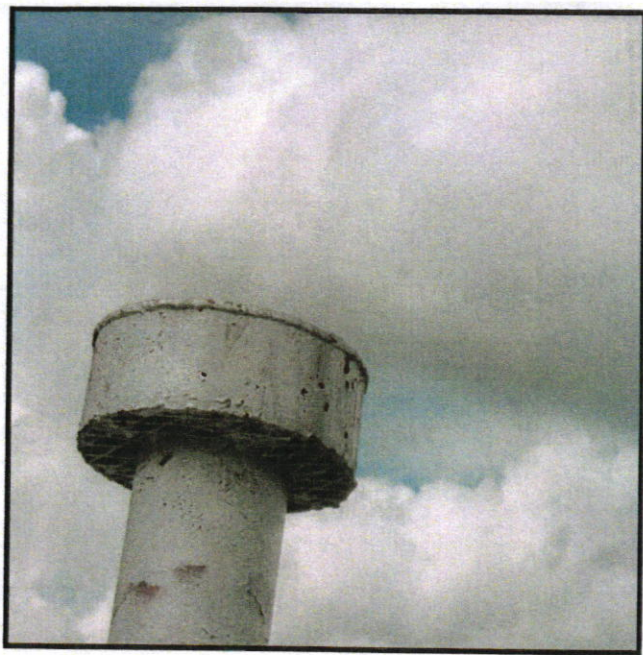
Roof vent does not meet current standard.

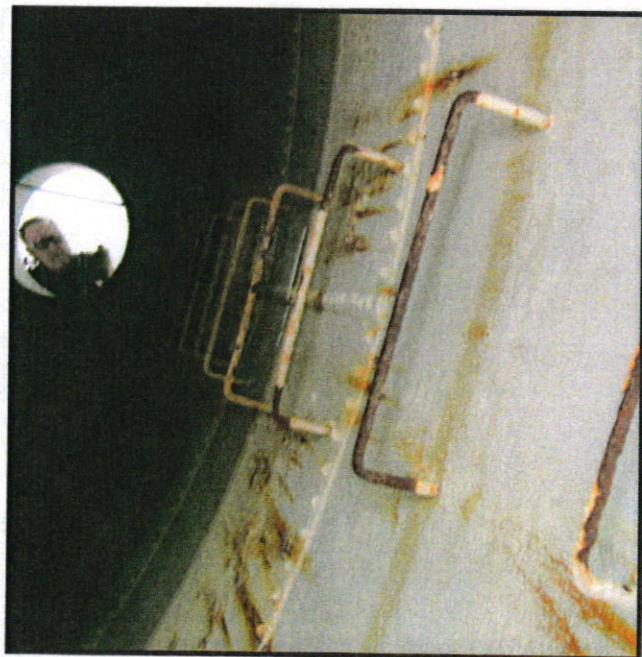
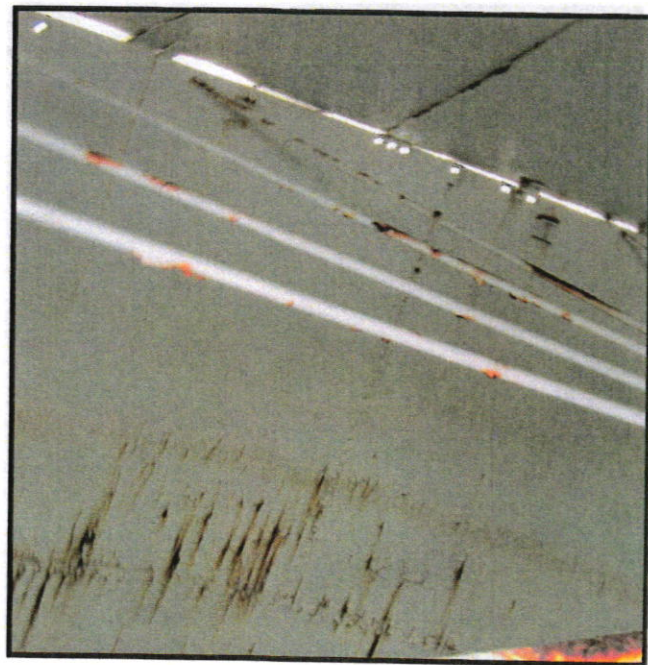
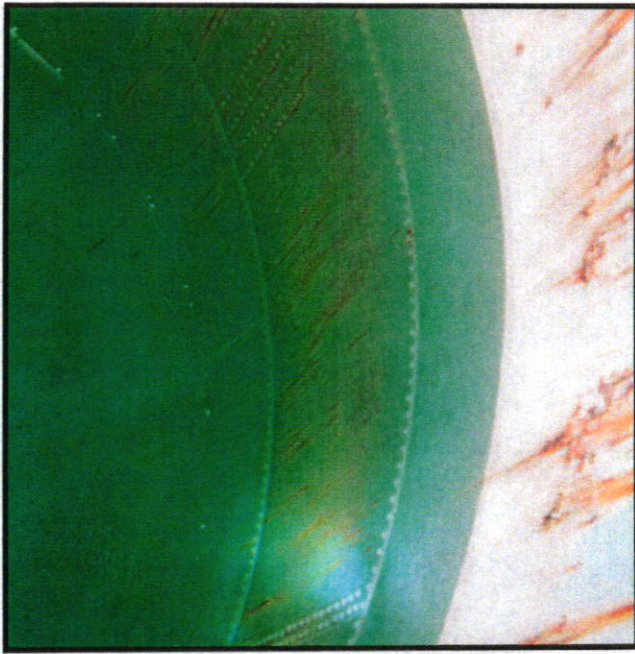
Tank interior wet coating failures.

- Interior coatings are failing in many areas, most notable on the sidewalls of the tank. The roof and belly coatings are in better condition. Recommend blasting and relining within the next 2-3 years.

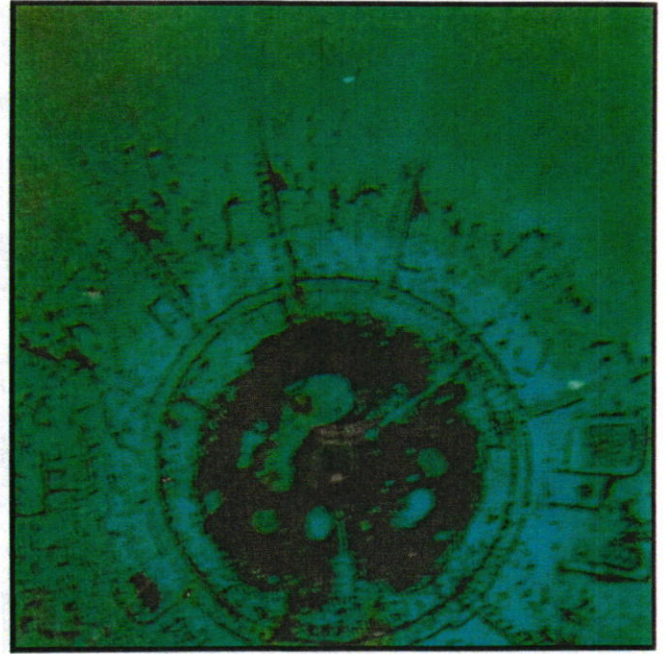
Light sediment in tank belly.

Sanitary Components:	Comments:	Standard:
	Roof Vent	Roof vent is not up to current standard.	N
	Overflow	Overflow properly terminates just above grade and has drainage.	Y
	Sediment	Recommend cleaning and disinfecting interior every 3-5 years. Some light sediment observed.

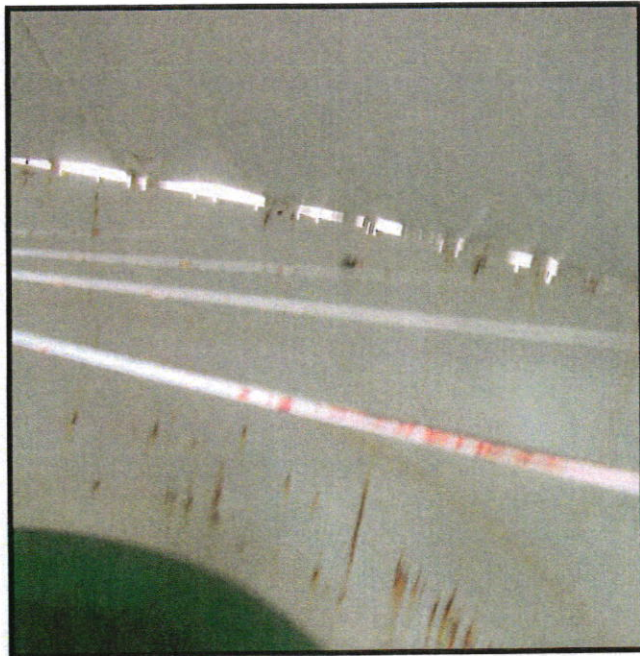
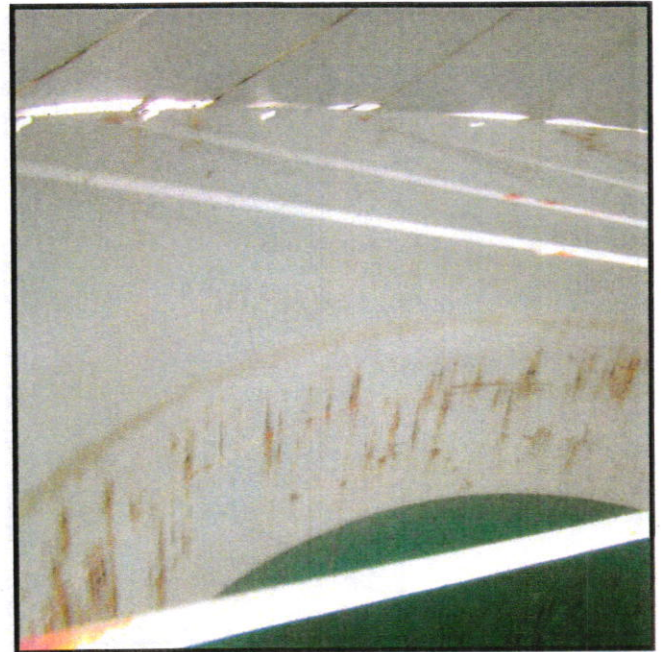
Coating failures. Eave gap opening. Spider rods.

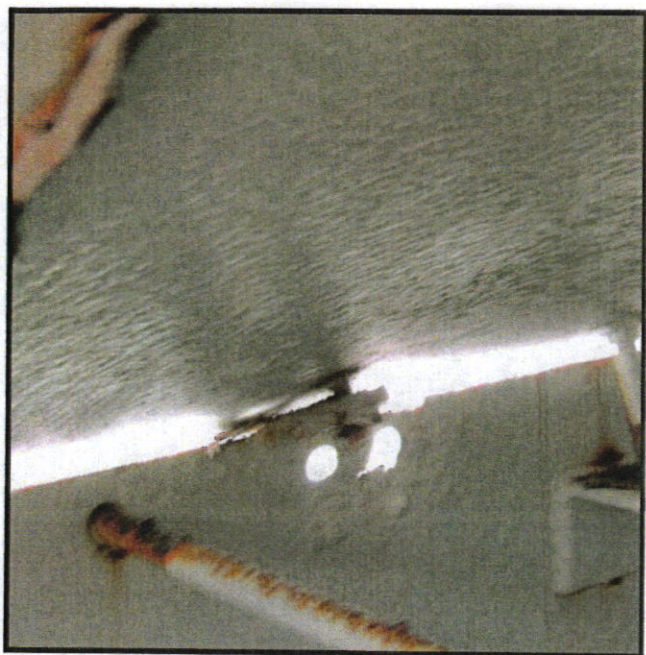
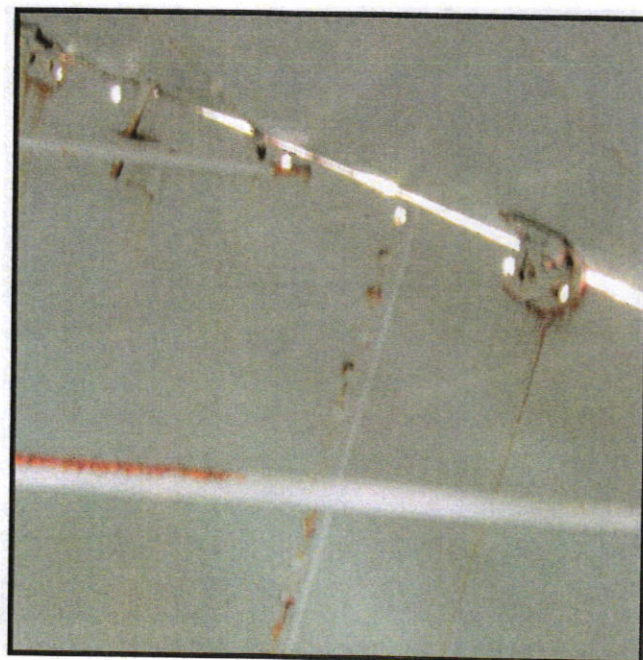
Roof eave opening.

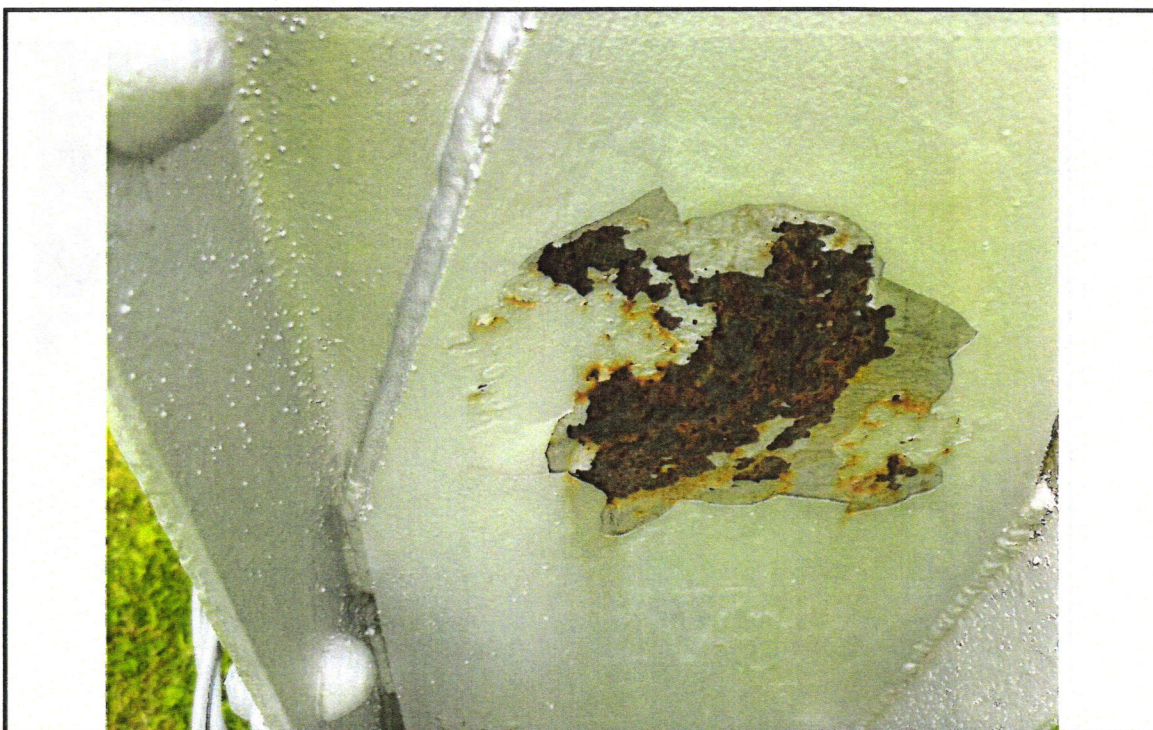
**Photo 4:** View looking at peeling paint on water tower base.

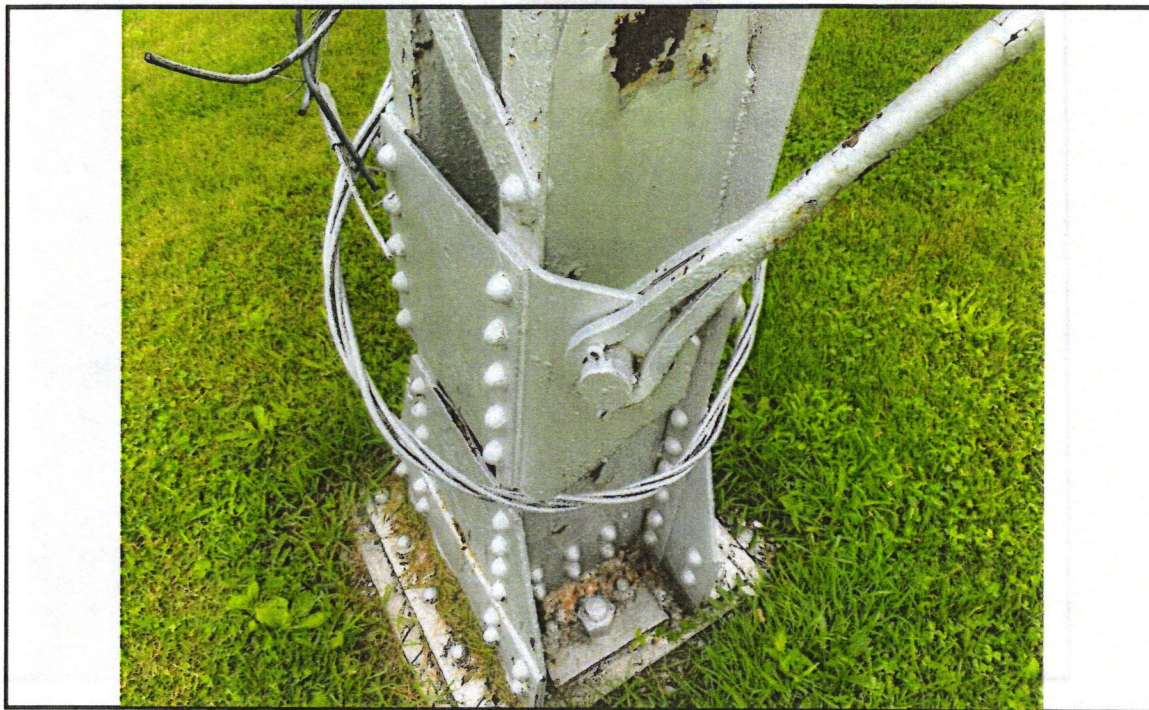
**Photo 5:** View looking at peeling paint on water tower base.
