**PRELIMINARY ENGINEERING REPORT  
FOR  
WATER DISTRIBUTION SYSTEM IMPROVEMENTS  
HEDRICK, IOWA  
2021**

Tower Visual Inspection Report  
Viking Industrial Painting  
July 2020

**Visual Inspection - July 2020**

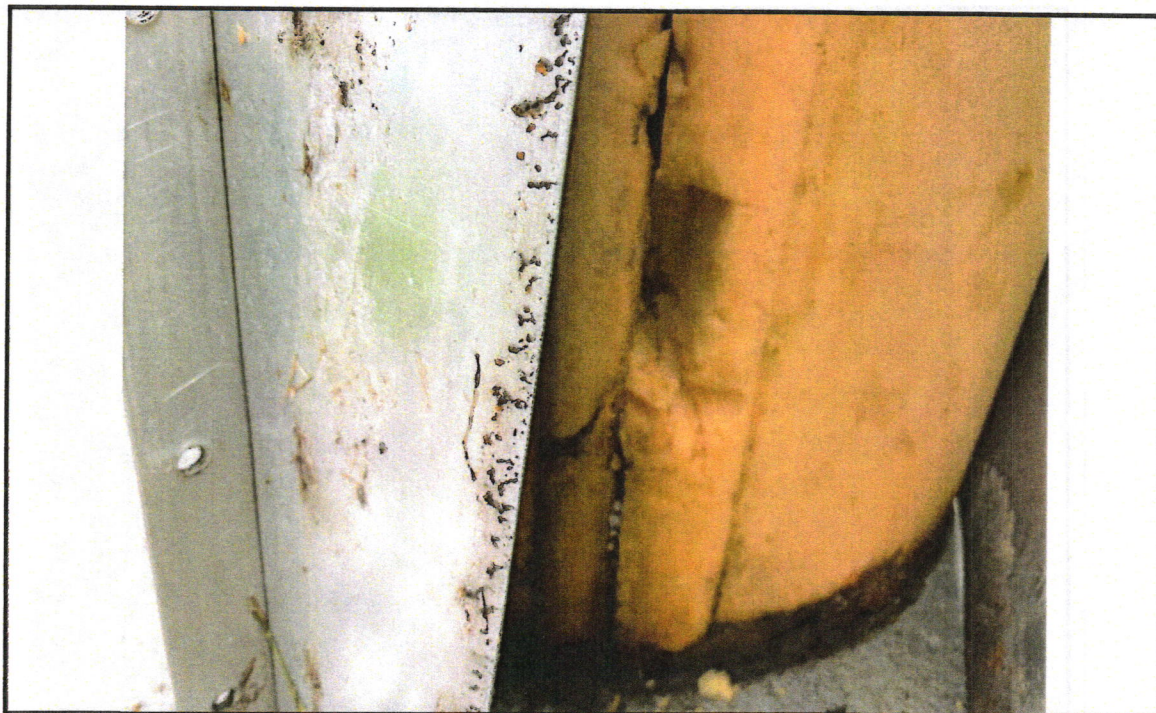
**Photo 7:** View of insulated pipe centrally located under water tower.

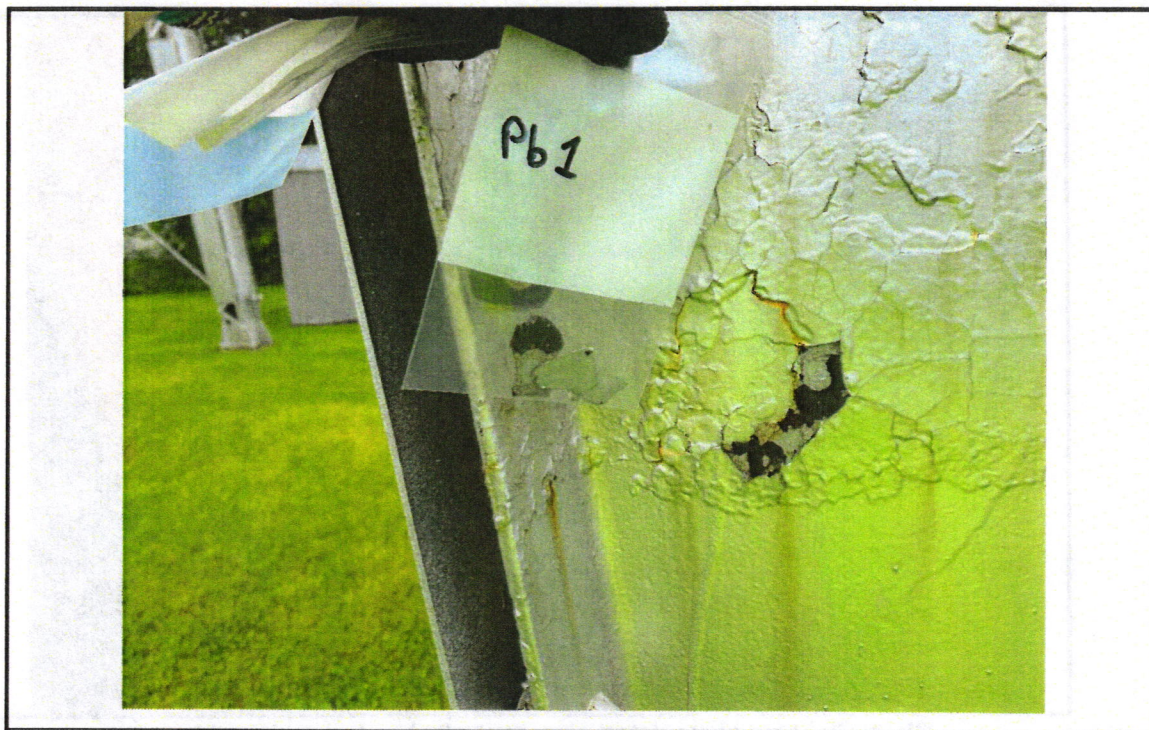
**Photo 9: Pb1/Cr1 silver paint.**

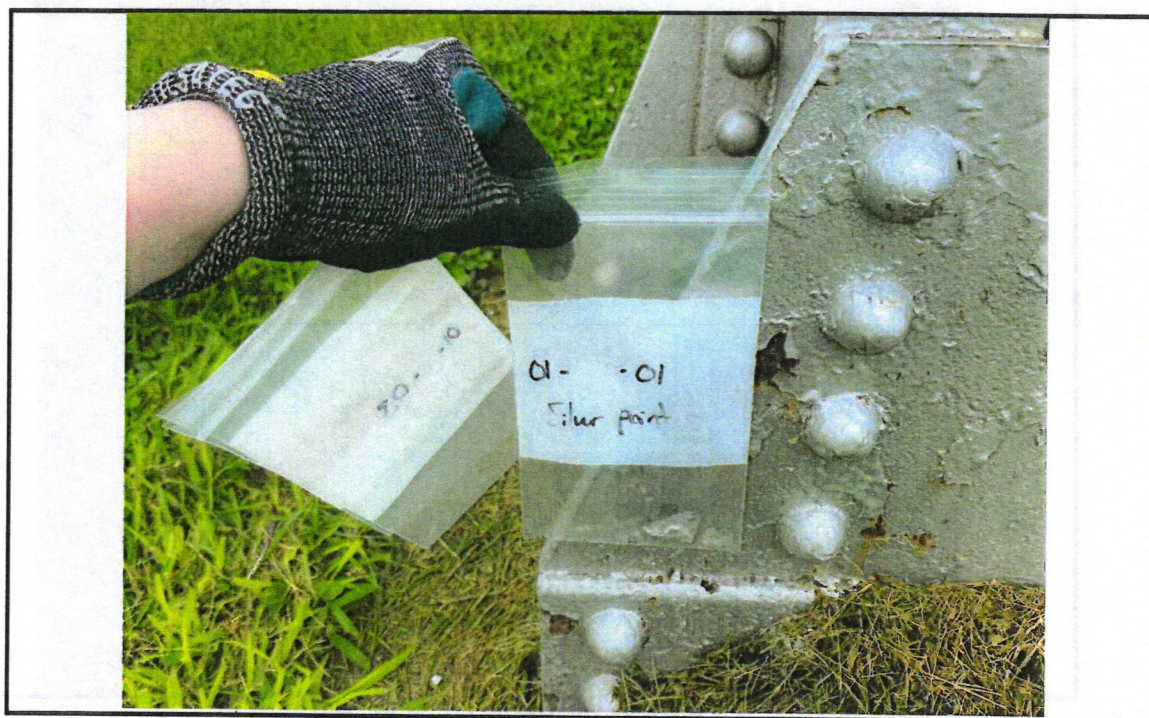
**Photo 10: Asbestos sample, HA-01 silver paint**
